FINAL REPORT

CLAY TILE INVESTIGATION NSP/ASHLAND LAKEFRONT ASHLAND, WISCONSIN

Xcel Energy, Inc.

February 19, 2002

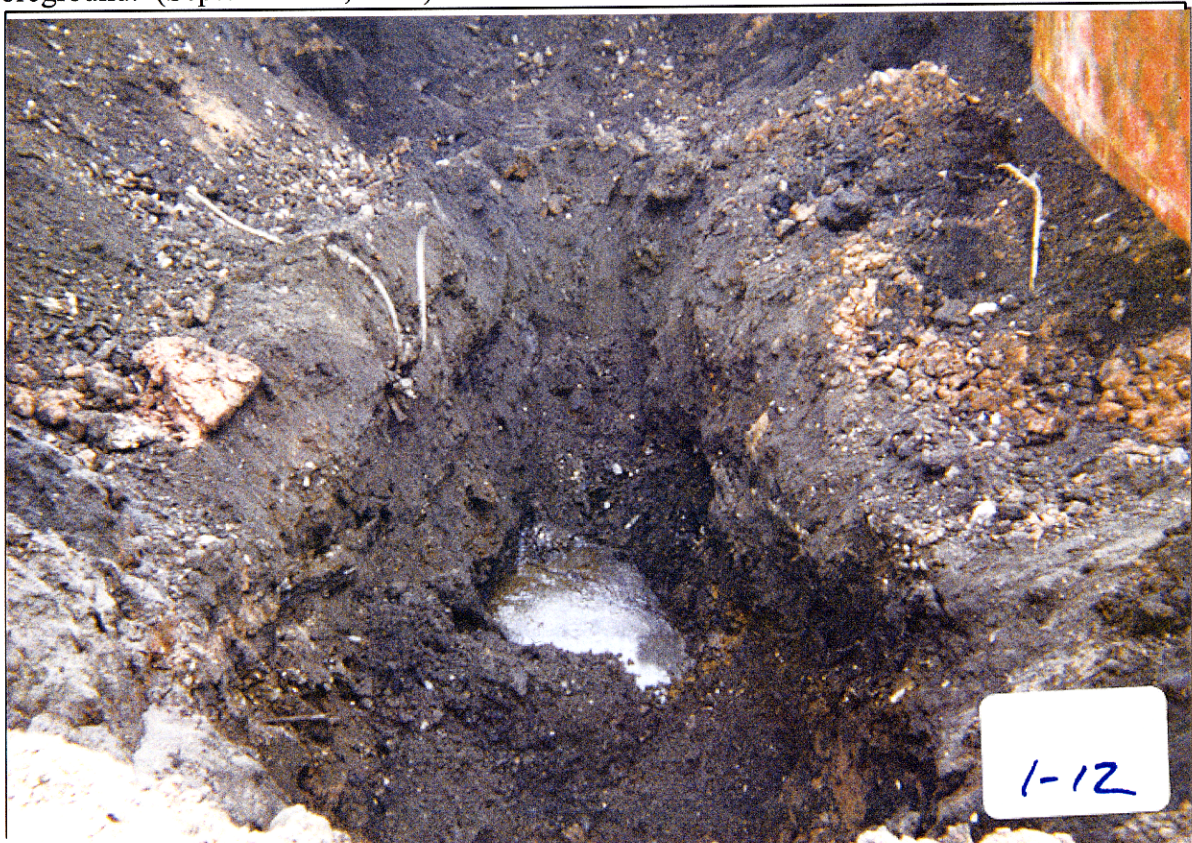
Photo 5 - Water seeping into base of excavation from clay tile when first encountered (clay tile below water level). (September 17, 2001)

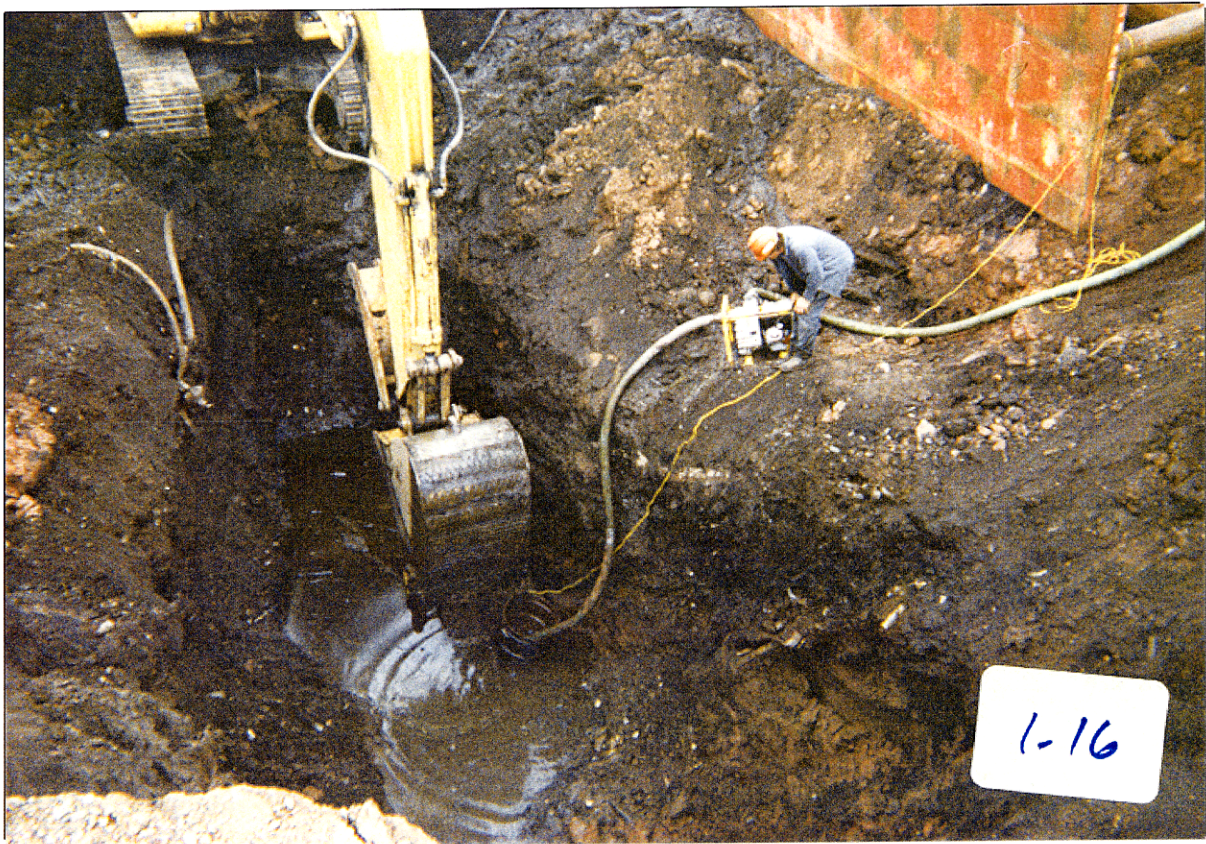
Photo 6 - Removing water that drained from clay tile from excavation. (September 19, 2001)

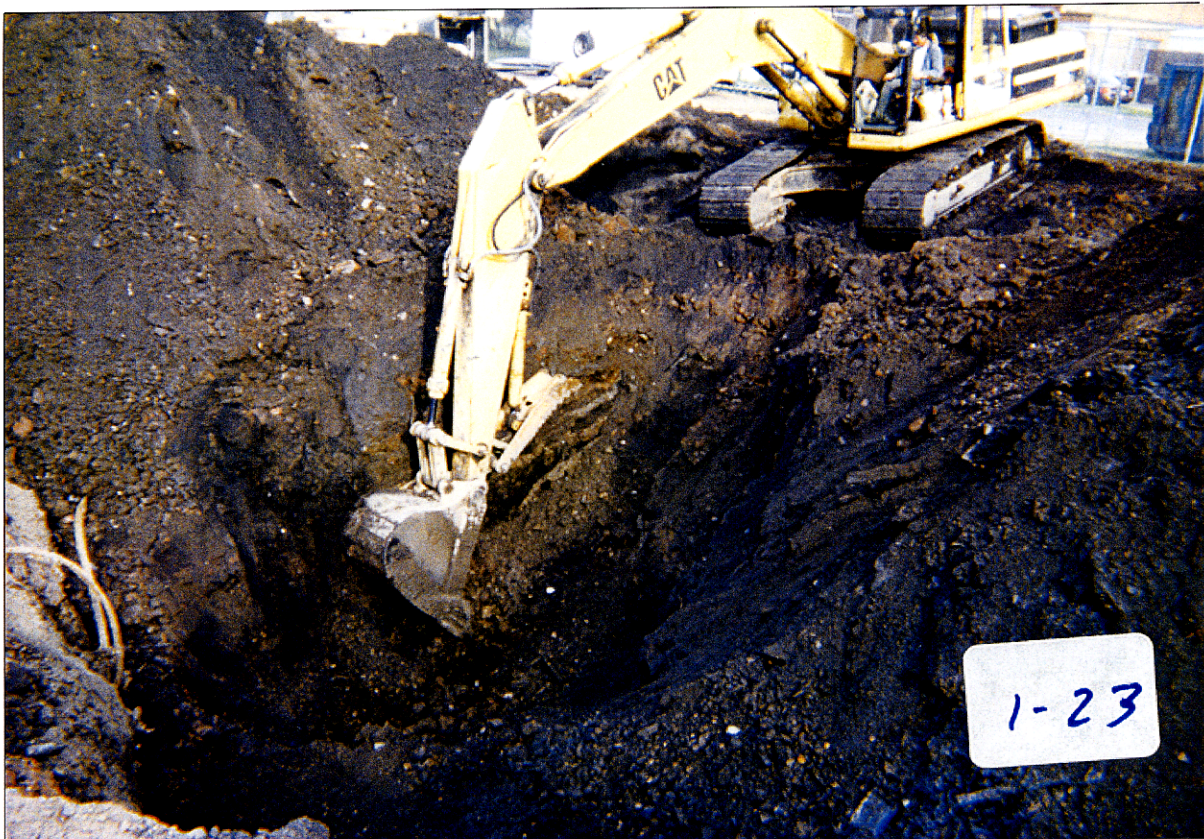
Photo 10 - Excavating along top of clay tile in area where probe could not be advanced any further. (September 19, 2001)

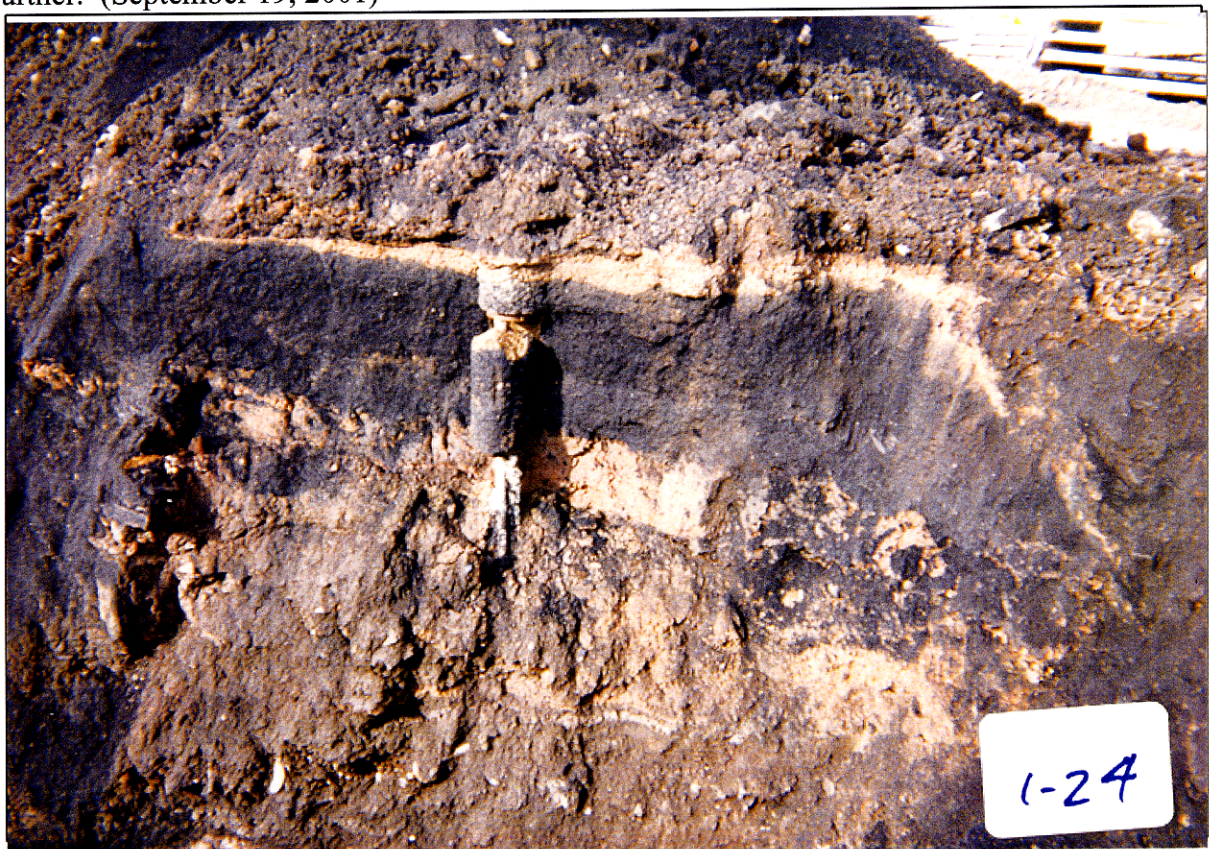
Photo 11 - Well MW-2B encountered in side wall of excavation prior to well being destroyed by collapsing side wall. (September 19, 2001)

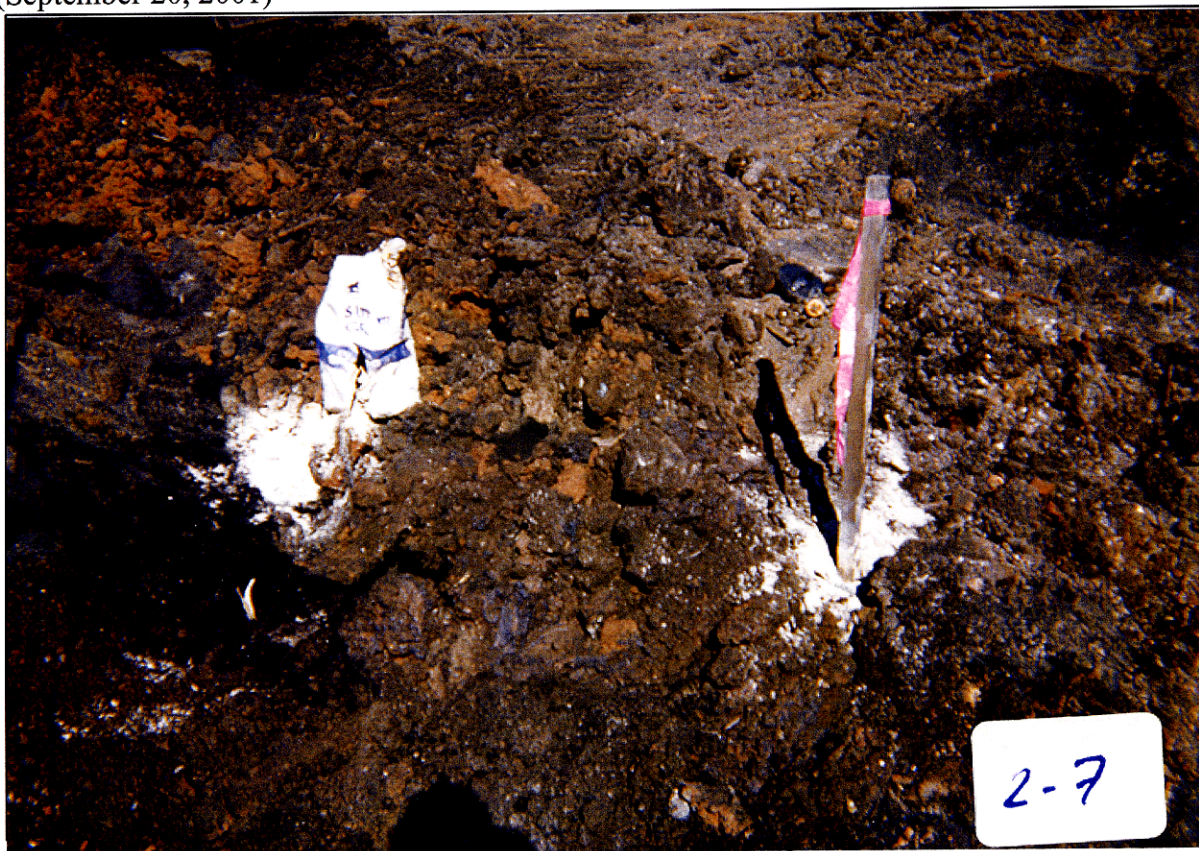
Photo 15 - Wells MW-2 and MW-2A after being abandoned with bentonite. Both wells were destroyed when excavation to locate MW-2B was completed. (September 20, 2001)

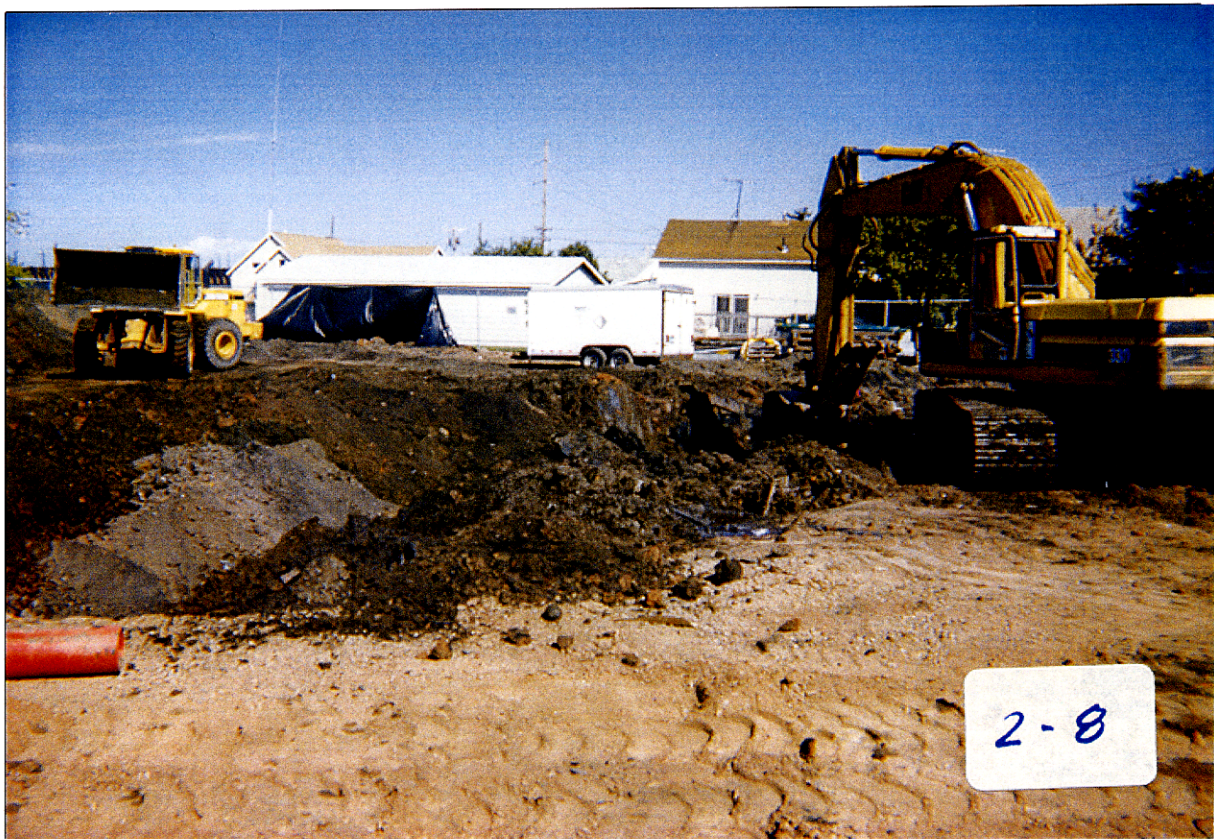
Photo 16 - Excavating to an approximate depth of 20 feet to locate well MW -2B which was destroyed when side wall of September 19, 2001 excavation collapsed. (September 20, 2001)

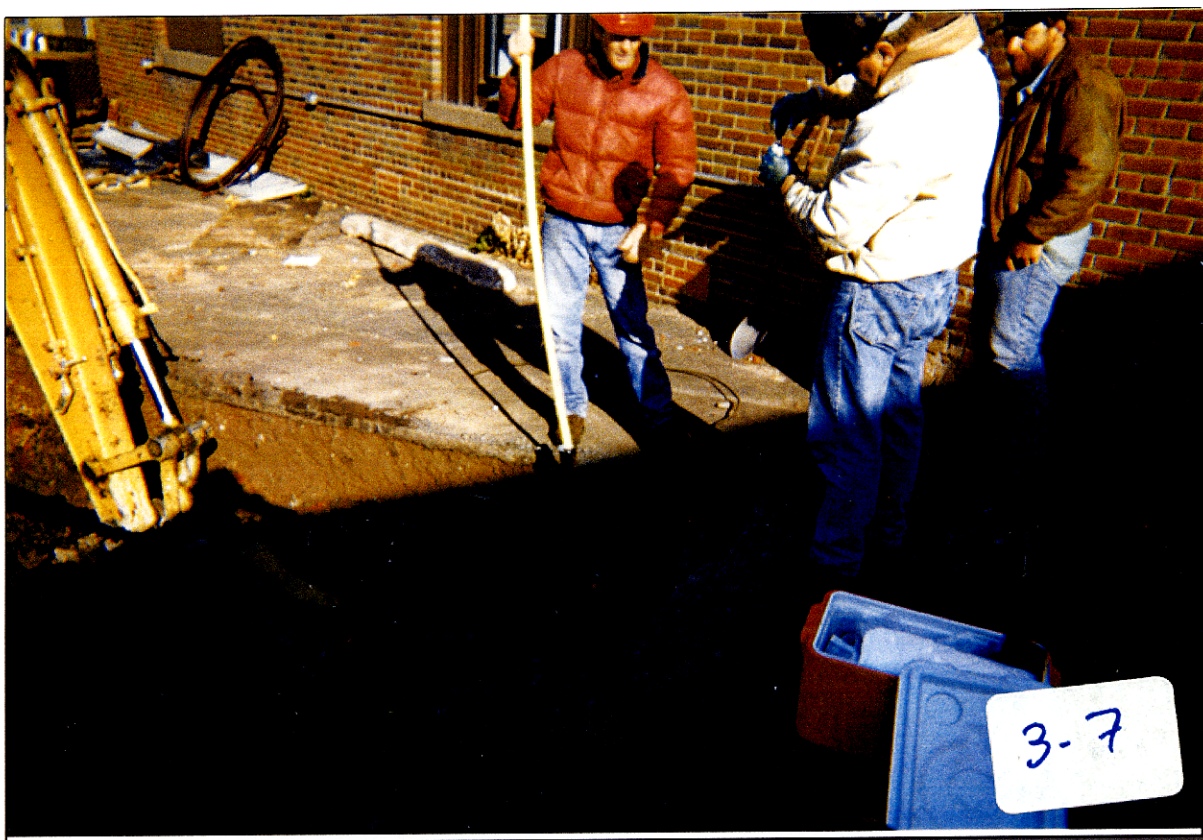
Photo 22 - Collecting sample of coal tar which seeped out of small diameter steel pipe encountered in courtyard excavation. (November 12, 2001)

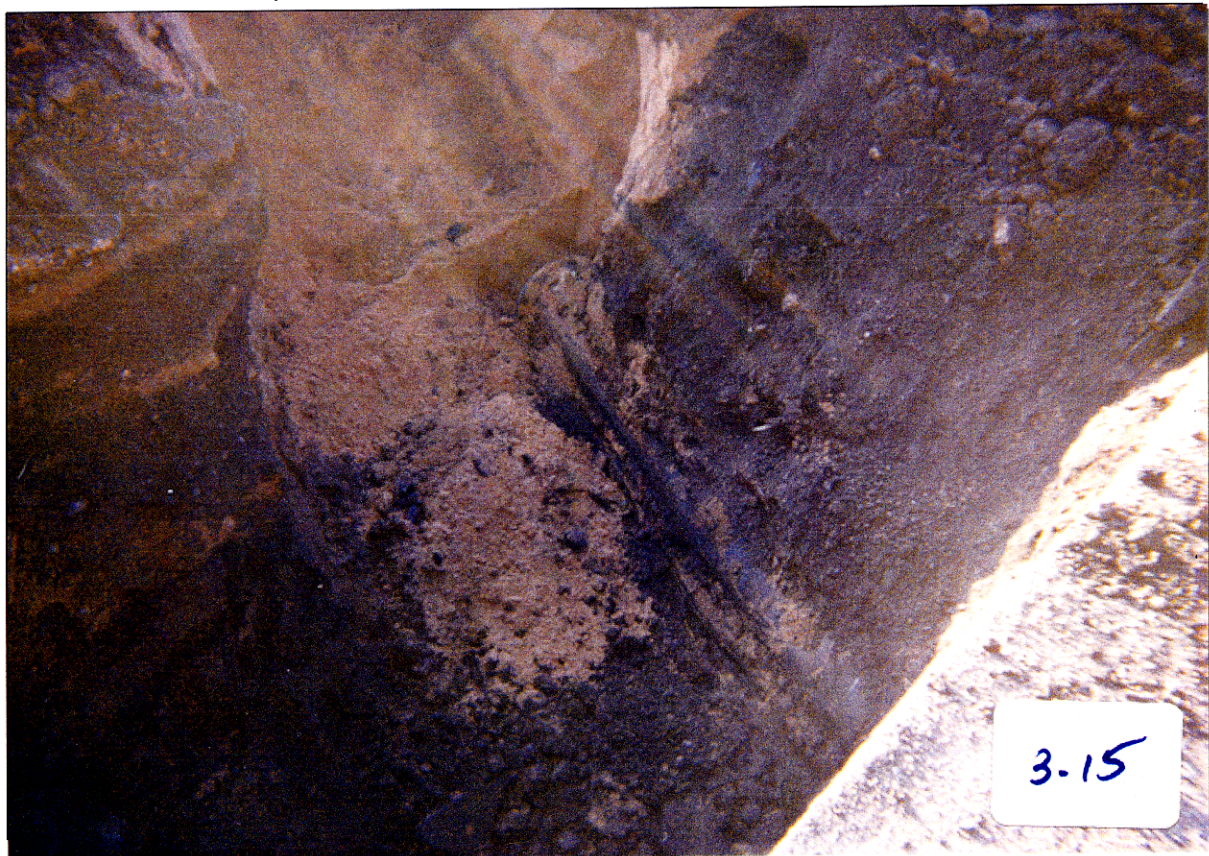
Photo 25 - Large diameter pipe encountered in courtyard excavation terminates in clean fill-sand encountered west of excavation in area of former tar well. (November 11, 2001)
